SERVICE BULLETIN no. 05/07/2019

CLOSING PIN FOR THE BRAKE PARACHUTES OF TANDEM PARACHUTE MarS-T

1. SUBJECT MATTER: Closing pins for the brake parachutes BP-01 T-1 and BP-04 T-1, used for Tandem parachute MarS-T.

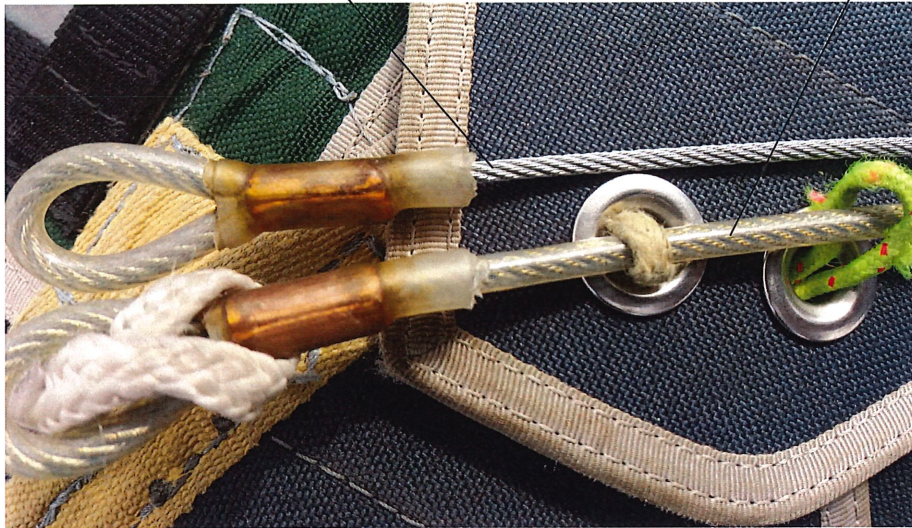
1. Closing pin photo

2. REASON: Notification of the user from Poland when the plastic coating of the cord was pulled down during the dive. The coating blocked the opening of the main parachute container. It was necessary to use the reserve parachute.

- damaged Closing pin

- non-damaged Closing pin

- During the inspection of the brake parachutes BP-01 T-1 and BP-04 T-1 during the packaging of the tandem parachute MarS-T for use, always perform thorough inspection of the Closing pins focusing on the completeness and intactness of the plastic cover over the metal pressed part and the part with the plastic coating.
In case of damage or shifting of the plastic coating on the rope metal part, and visible gap between individual plastic parts, immediately replace the Closing pin with new - non-damaged part.
- During the inspection of the tandem parachute before the dive, always thoroughly check the Closing pin.
In case of damage proceed identically as specified in the point above.
